# **FABRICATION AND VERIFICATION TESTING OF ETM 30 CM DIAMETER ION THRUSTERS**

**FINAL REPORT**

**ION PHYSICS DEPARTMENT STAFF  
HUGHES RESEARCH LABORATORIES  
A DIVISION OF HUGHES AIRCRAFT COMPANY  
3011 MALIBU CANYON ROAD  
MALIBU, CALIFORNIA 90265**

**CONTRACT NAS 3-17803  
JAMES S. SOVEY, PROGRAM MANAGER**

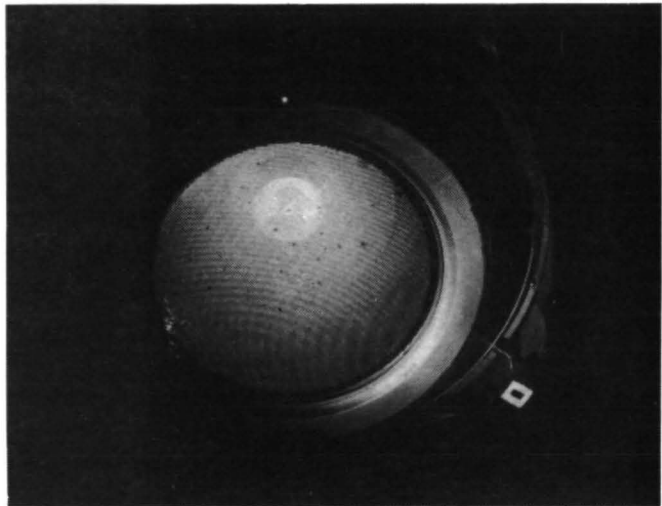
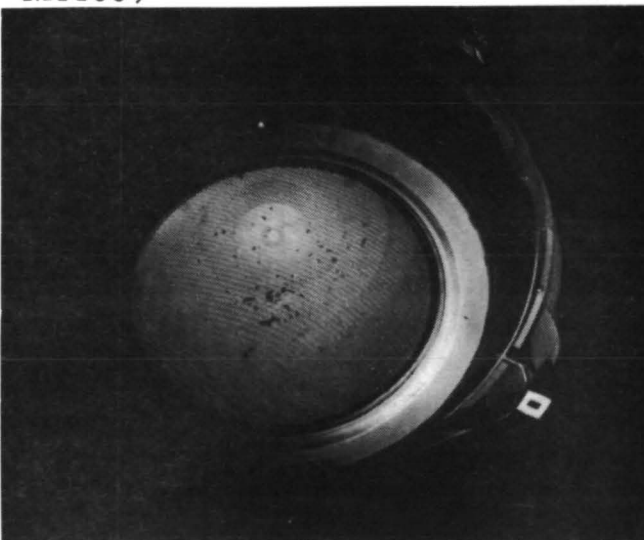
The first evidence of thruster discharge chamber erosion was the observation at test hour 4530 of flakes lying on the upstream side of the screen grid (the thruster was mounted in the vertical vacuum chamber pointing down at a frozen mercury collector). The number and size of flakes varied as the test continued; Figure 31 illustrates this by showing the flakes at test hours 8600 and 10,000. Some of the erosion of the accelerator electrode apertures caused by the flakes is shown in Figure 32. In that figure, the uneroded apertures adjacent to eroded apertures demonstrate the localized nature of the erosion. The source of flakes on the screen electrode is presumed to be spalling of the material which had been sputter eroded from within the discharge chamber and deposited on other discharge chamber surfaces. This theory was substantiated at test hour 5845 when a small hole was observed in the center of the cathode baffle. The cold-rolled steel baffle had originally been 0.075 cm thick. The maximum dimension of this hole when first observed was approximately 0.4 cm. Additional erosion of the cathode baffle then appeared at two locations on the edge (see Figure 31). The two regions of edge erosion began diametrically opposite each other and appeared to be coincident with the axis of the cathode keeper; the cathode keeper is mounted 1.7 cm upstream from the baffle. The condition of the baffle at the conclusion of the 10,000 hr test is shown in Figure 31.

Figure 31. Thruster at test hours 1800, 8600, and 10,000 showing flakes on the optics and erosion of the baffle.

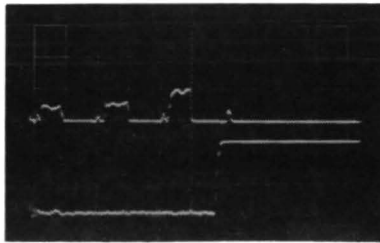
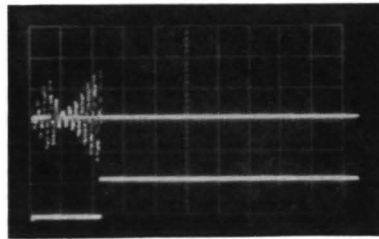
At the conclusion of the test console modification effort, there was one problem which had not been completely eliminated. During thruster integration testing, occasional perturbations in the controller logic circuits occurred when thruster overloads were induced by generating high-voltage shorts external to the vacuum system. These perturbations would manifest themselves as false alarms or resets to earlier start-up sequence states. The problem was not evident during smooth thruster operation or naturally occurring arcs. The source of this behavior is thought to be electrostatic coupling between circuits at power processor common and circuits at earth ground. Filtering of logic supply bus voltages and input-output signals did not eliminate the problem.

Figure 35. Screen supply and accel supply inverter current during overload conditions.

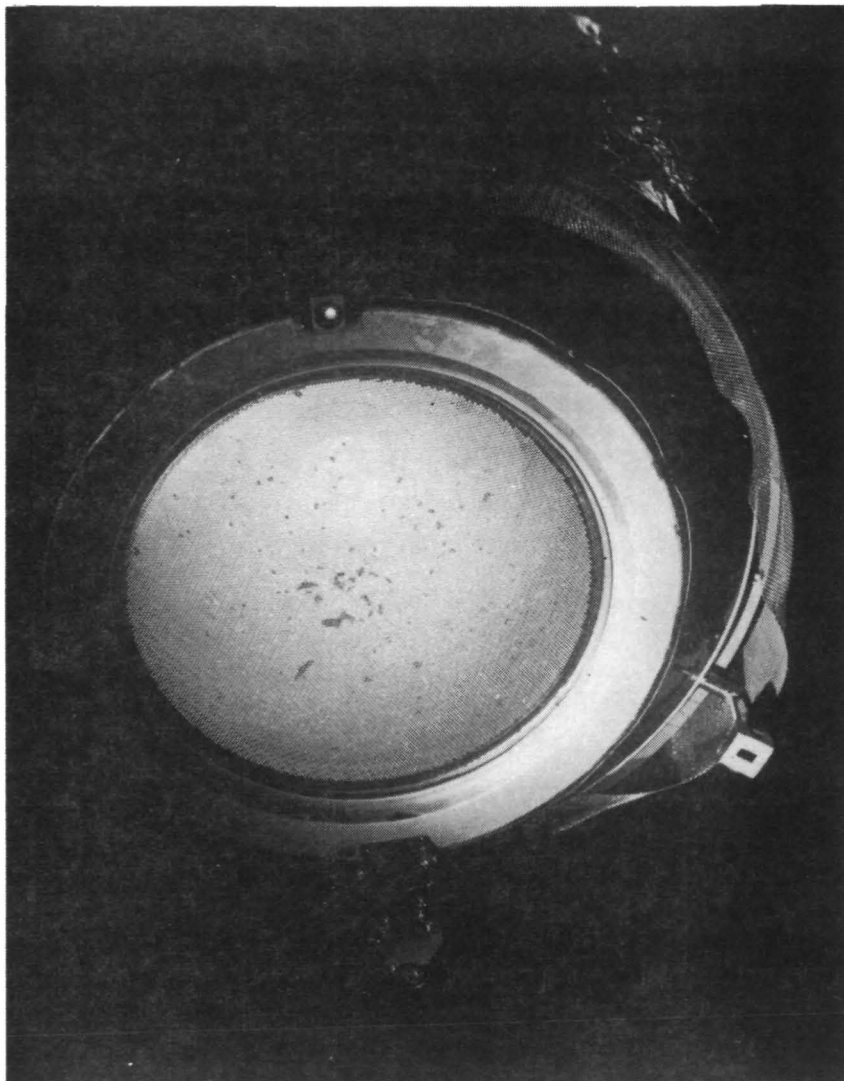
This section presents the documentation and observations that relate primarily to the complete thruster assembly. Component wear is noted; however, the detailed discussion of such wear is deferred to later sections. A photograph of the thruster taken during the final hours of testing is shown as Fig. A-1. On the ion optics assembly can be seen the damage to the accelerator grid and also the "flakes" of material that partially block screen grid holes. These flakes cause the deflection of the ion trajectories which, in turn, causes the damage. Erosion of the baffle is also visible, and a "severed" portion of the baffle is identified by a circle where it lies on the screen grid. The comparable portion of the opposite side of the baffle has not yet been severed, and is identified by an arrow. The operating neutralizer (SN 701) is seen nearer the top of the figure. In Figs. A-2 and A-3, the thruster is seen as it appeared upon removal from the test facility. The most notable observances on the thruster exterior are the coatings on the downstream surfaces of the thruster's outer case and unused neutralizer, XN 415 (see Figs A-2(c) and A-3(a) and (b)), the machining of the outer case of neutralizer SN 701 (operating neutralizer throughout the test (see Fig. A-2(d)), and the machining of the accelerator grid (see Fig. A-3(d)). Samples of this flake material taken from the locations shown in Fig. A-4 were analyzed to yield the elemental composition listed in Table A-1. Note that the flakes from locations I and II are composed predominantly of iron and also have a high chromium content. These deposits are considered to be constituents of stainless steel sputtered by the ion beam from either the collector during preliminary thruster testing at HRL or the cryowall during the endurance test at SSL. Note that the sample from location III, though similarly located to I and II, is composed predominantly of molybdenum. Location III has a reduced view factor for the cryowall, since it is in the shadow of neutralizer SN 415. Because the view factor for the beam target

Figure A-1. Thruster during final hours of 10,000 hr test.

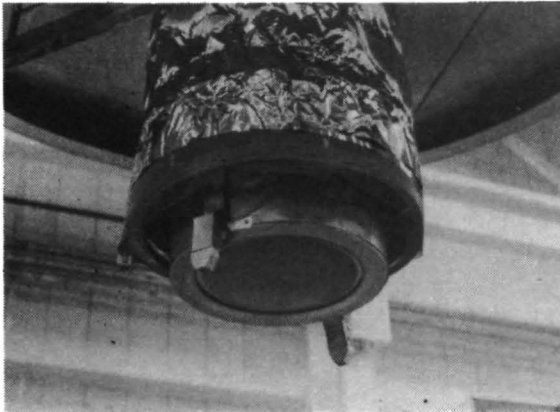
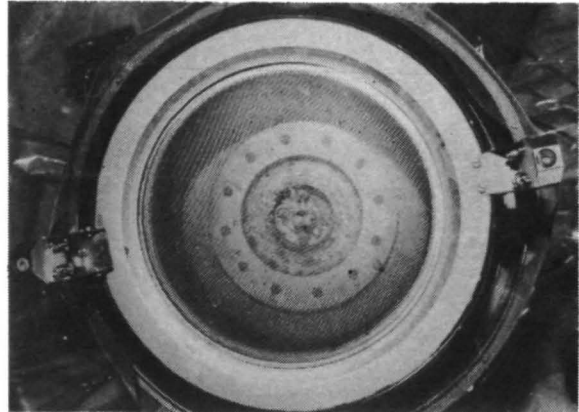
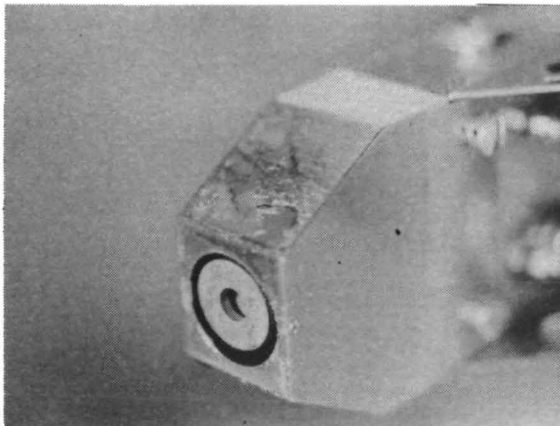
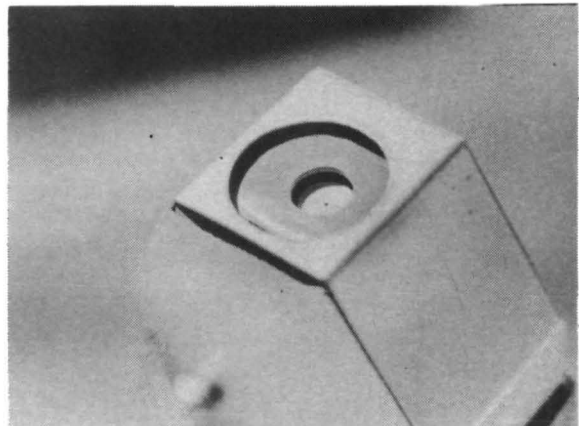
Figure A-2. (a) Thruster SN 701 being removed from endurance test facility. (b) Downstream view. (c) Neutralizer SN 415. (d) Neutralizer SN 701.

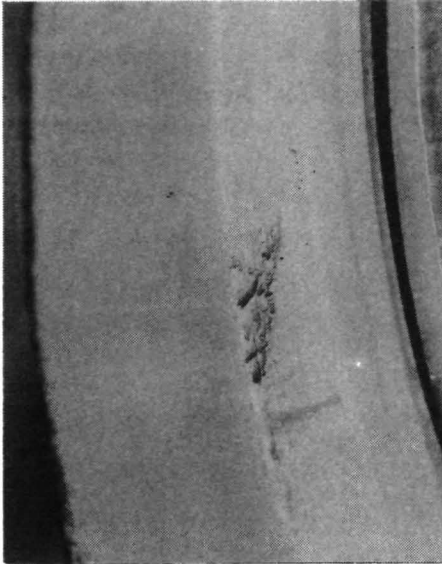
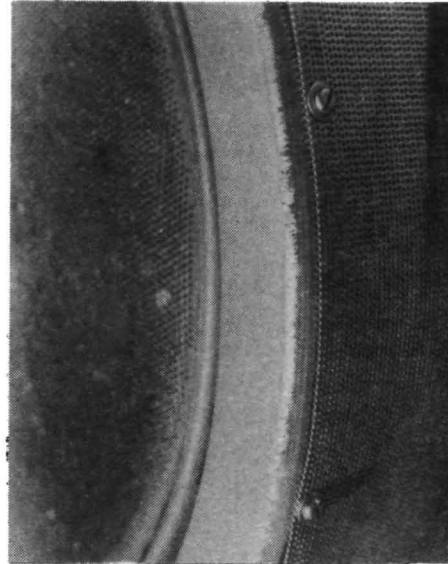
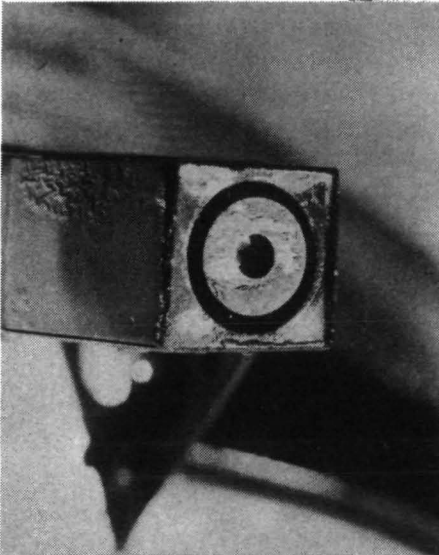
Figure A-3. (a) Deposition on downstream surface of outer case mask. (b) Deposition on neutralizer SN 415. (c) Damage to accelerator apertures.

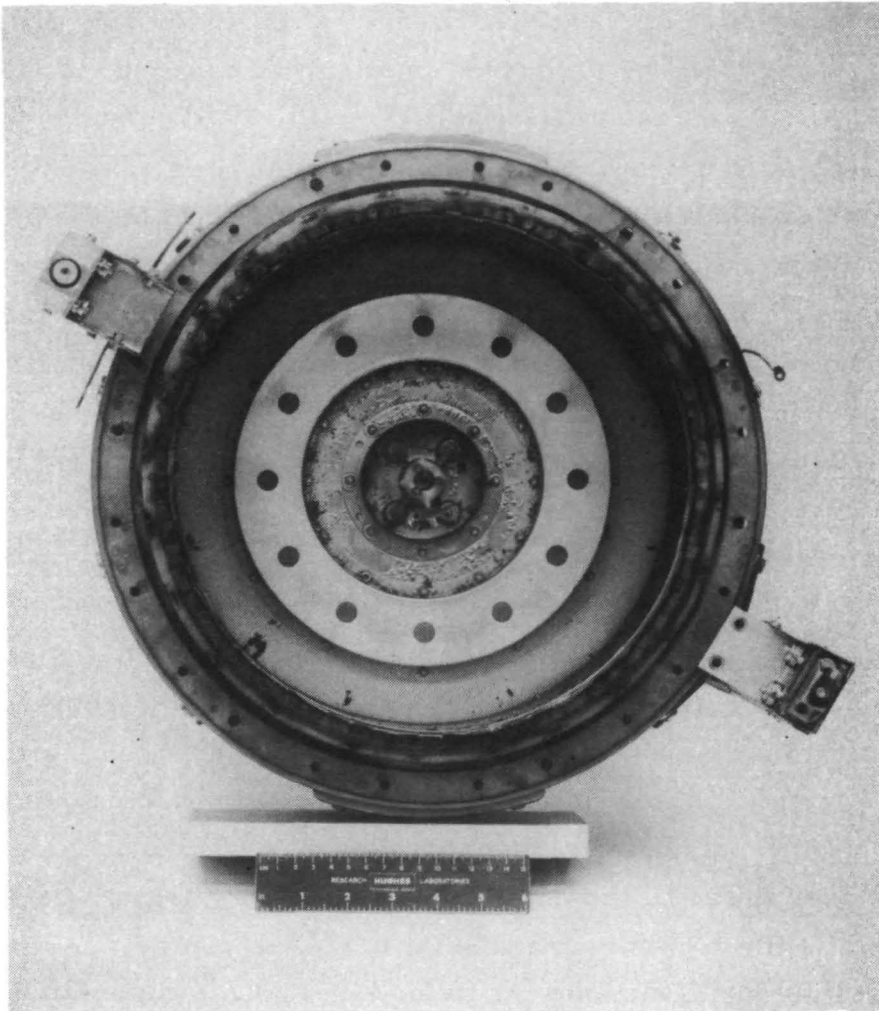
Views of the thruster assembly taken during initial disassembly are shown in Figs. A-5 through A-12. In Fig. A-5, the major wear of the thruster baffle and cathode pole is visible as well as its consequence, the deposition of the sputtered material on the thruster backplate and anode. This wear and its consequences will be discussed in detail in the following sections covering the discharge chamber assembly and the cathode pole/baffle assembly.

Figure A-5. Thruster 701—front view with optics removed.

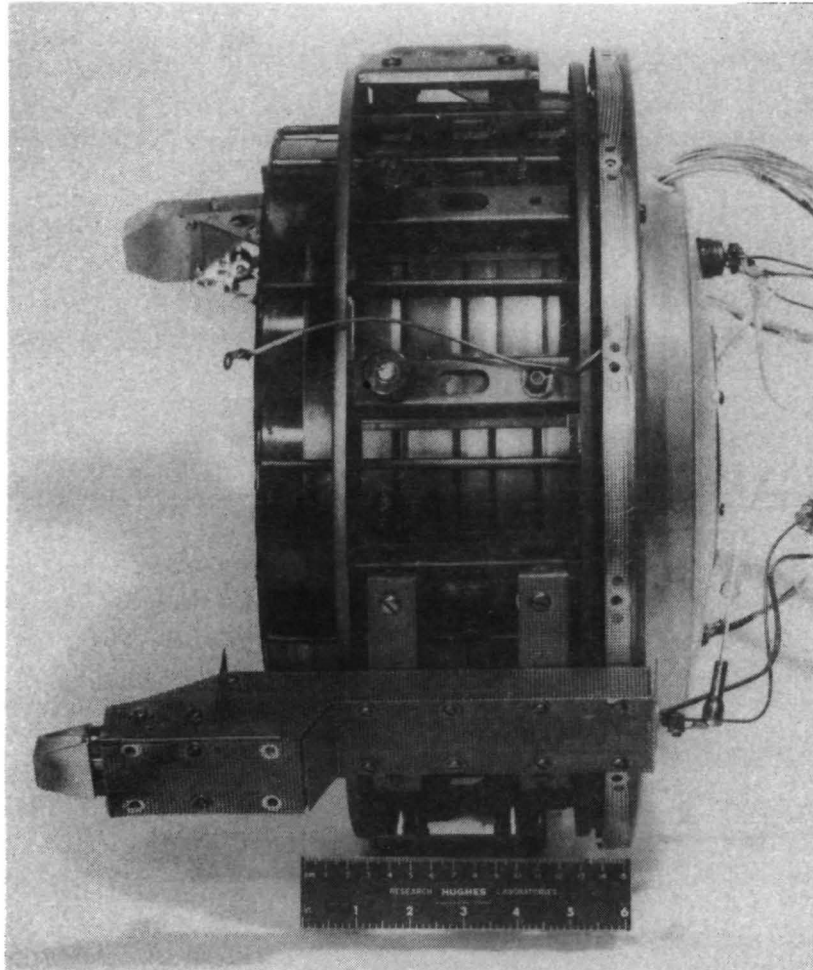
Figure A-7. Thruster 701—side view with ground screen removed.

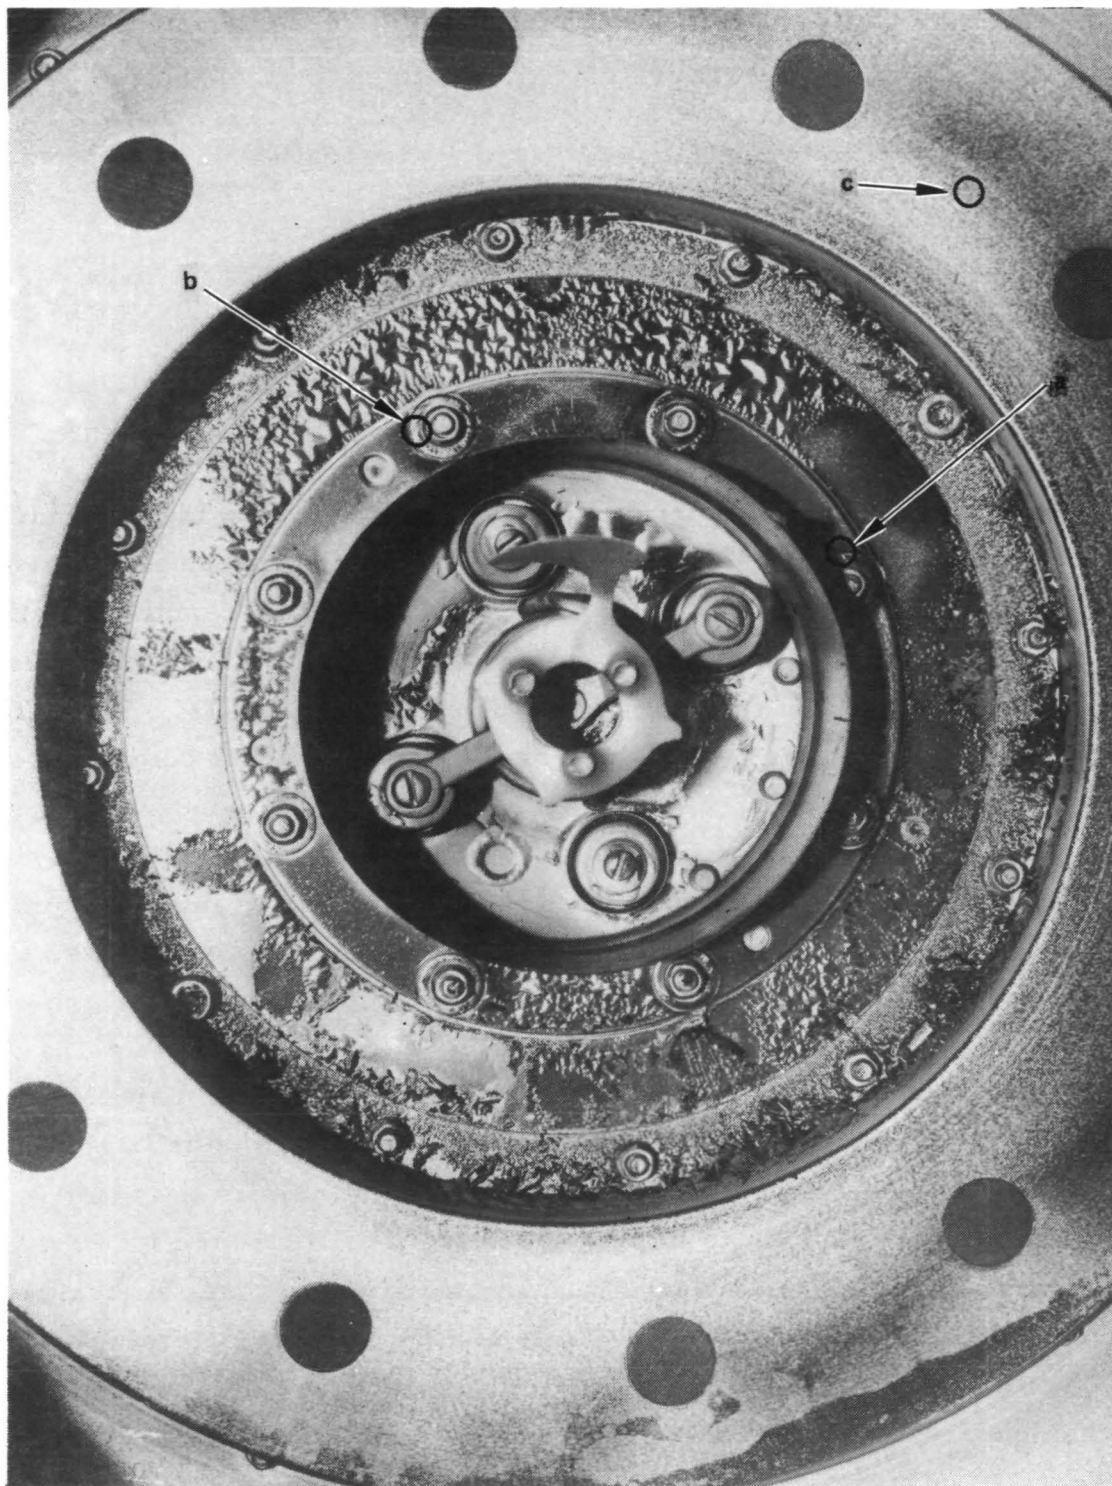
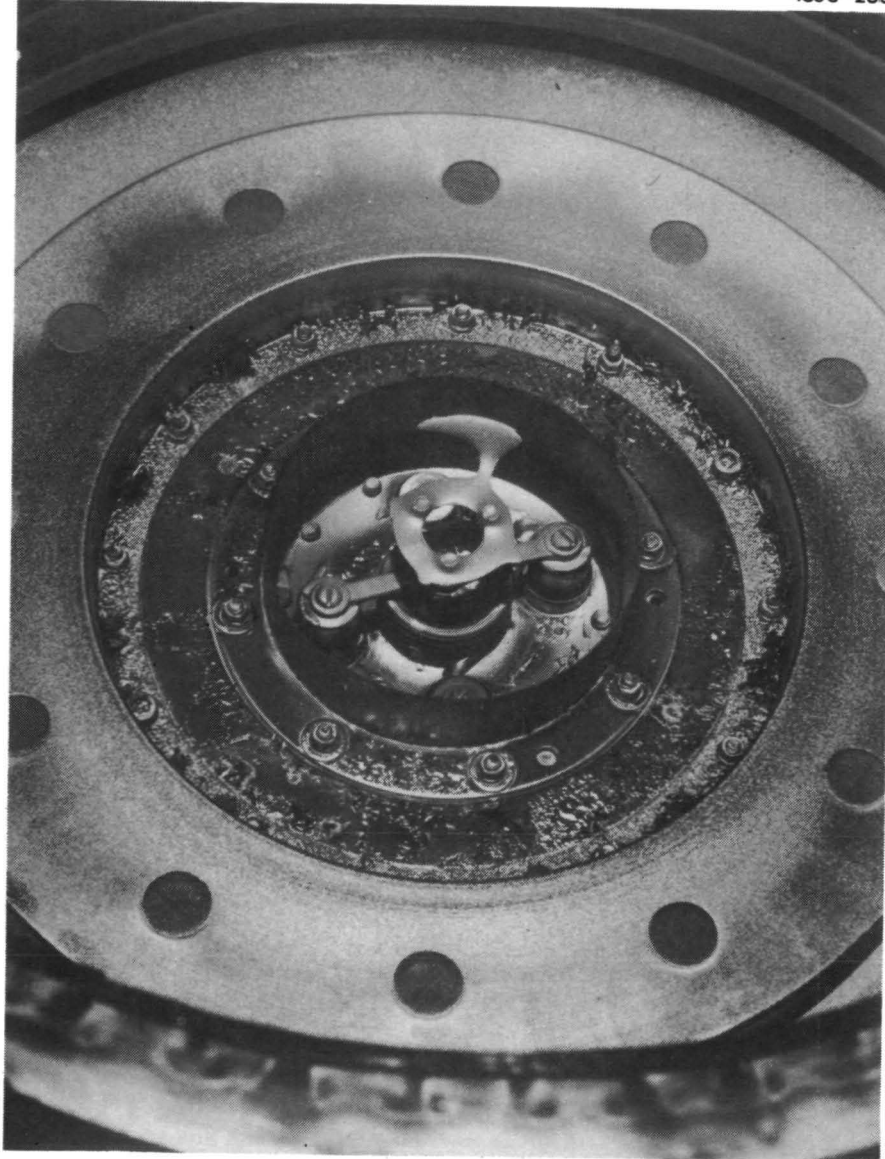
Erosion of the baffle and cathode pole piece by ion sputtering were concluded to be the major problem areas. All major damage could be related to either the removal or deposition of material which results from this process. Precise assessment of erosion sites and erosion rates was not possible because of the almost complete destruction of the baffle and the resultant exposure of the cathode and baffle support members to high-energy discharge ions. Definite erosion sites included the baffle, the cathode pole piece (downstream of the plane of the cathode), and to some extent probably the baffle support structure. Deposition sites included the anode, all thruster boundaries in the plane of or upstream from the cathode, and the cathode keeper. Discharge chamber surfaces which were not obviously eroded or coated included the downstream surface of the propellant distributor and the screen pole piece.

All of these elements (except the last) will be discussed in detail in this section. The cathode pole-baffle subassembly sustained the greatest wear, and its elements will be described in detail in another section. Figures A-13 and A-14 show the extent of this wear. (For comparison, a photograph of a new subassembly is shown as Fig. A-15.) The baffle is eroded almost completely away, exposing the internal components of the subassembly to ion bombardment. Similarly, the pole piece is seen to be thinned to a "knife-edge" at the downstream edge. The material removed from these components is re-deposited on the internal surfaces of the discharge chamber, and, as the coating builds in thickness, the deposited material spalls and forms "flakes." These deposits are evident in Figs. A-13, A-14, A-16, and A-17 primarily on the upstream discharge chamber boundary or backplate and the anode. Samples of these deposits were taken at the locations marked on the photographs in Figs. A-13 and A-16 and analyzed to provide the results listed in Table A-4. Except for the deposit taken from the outboard location on the backplate (L), the samples were comprised predominantly of iron. The sources of this iron are the baffle and the cathode pole which are fabricated from cold rolled electrolytic steel. The other constituents and impurities anticipated to be present in steel are also in evidence.

Figure A-13. Cathode pole-baffle region.

Figure A-14. Cathode pole-baffle region.

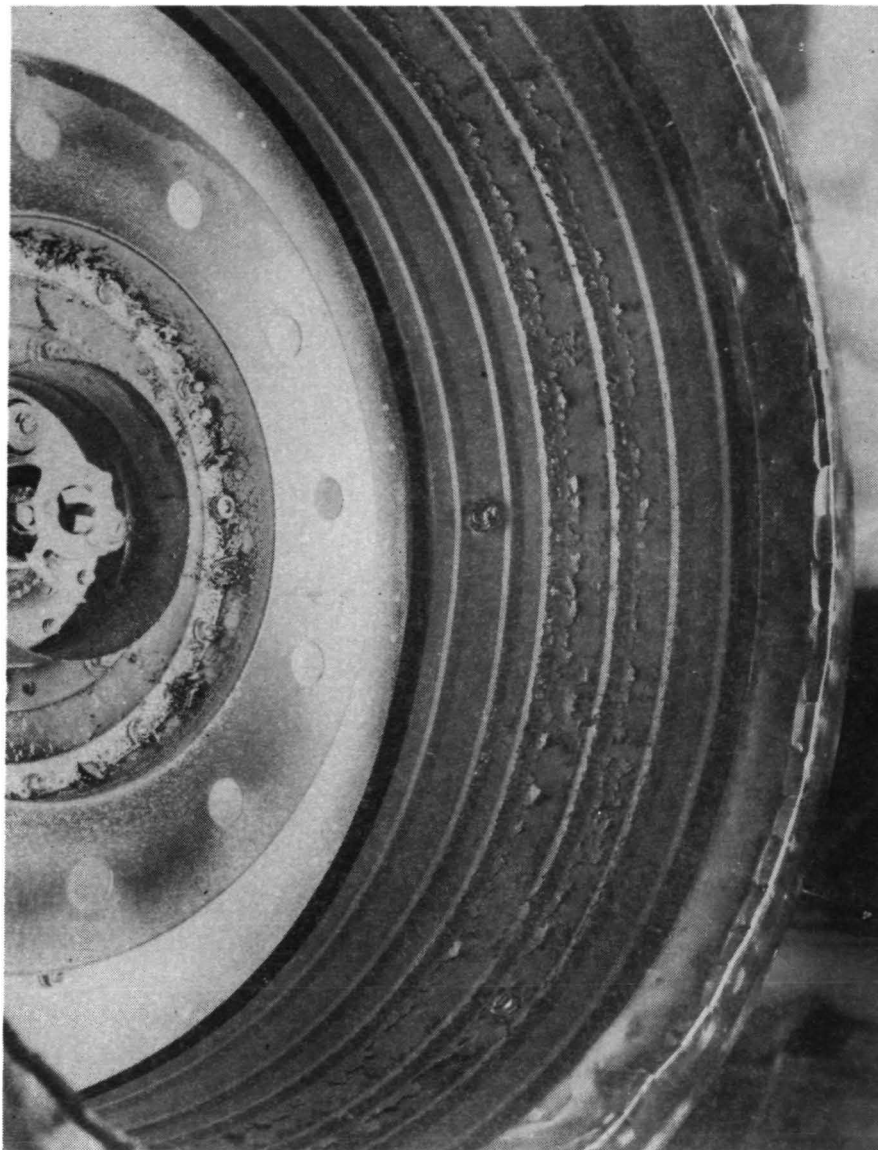
Figure A-17. Sputter deposition on anode.

Re-entrant shielding should be used where space permits and/or isolation requirements demand minimum leakage current. It is thought that damage to insulators, such as observed in the case of the anode insulators, will be eliminated by protection from conductive coatings.

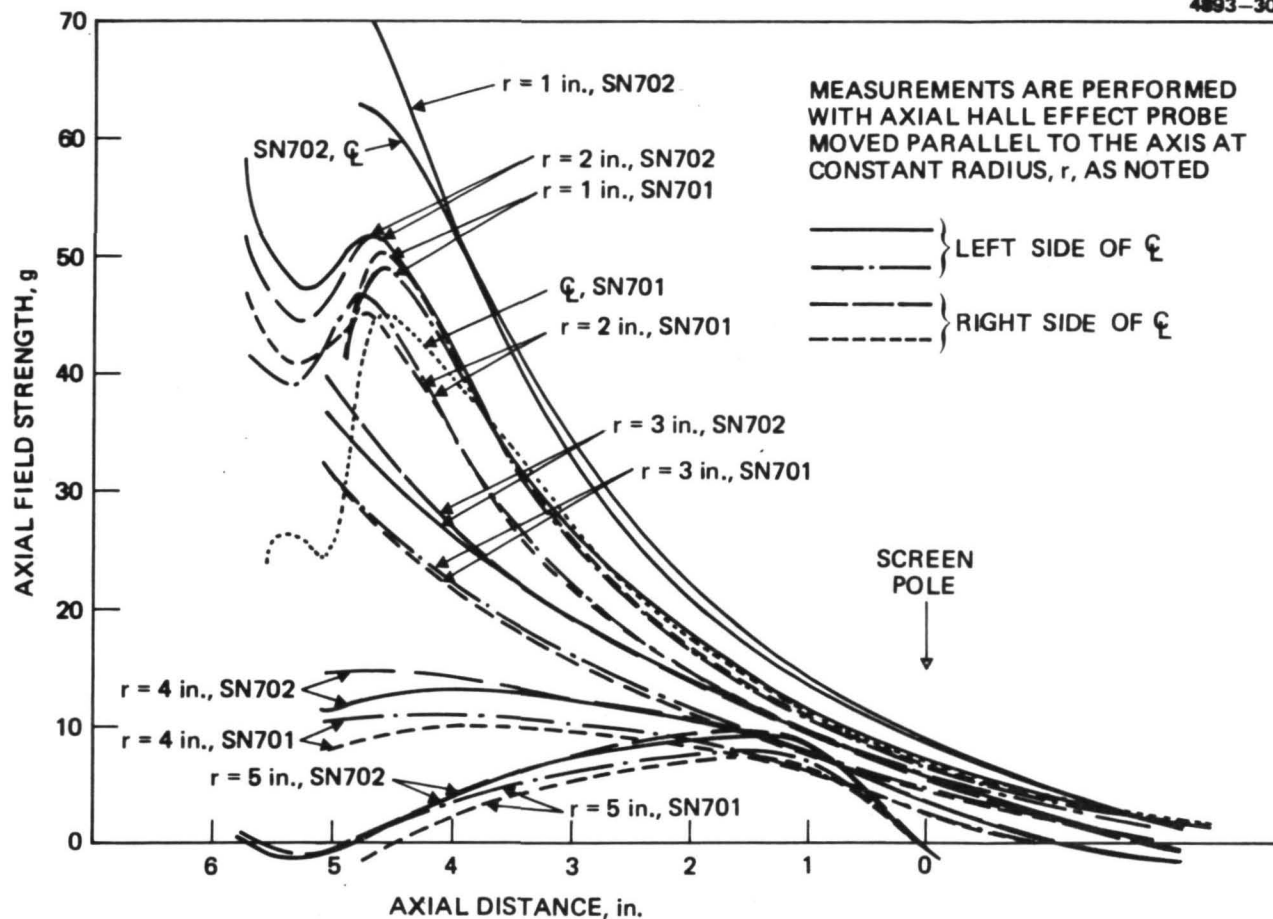
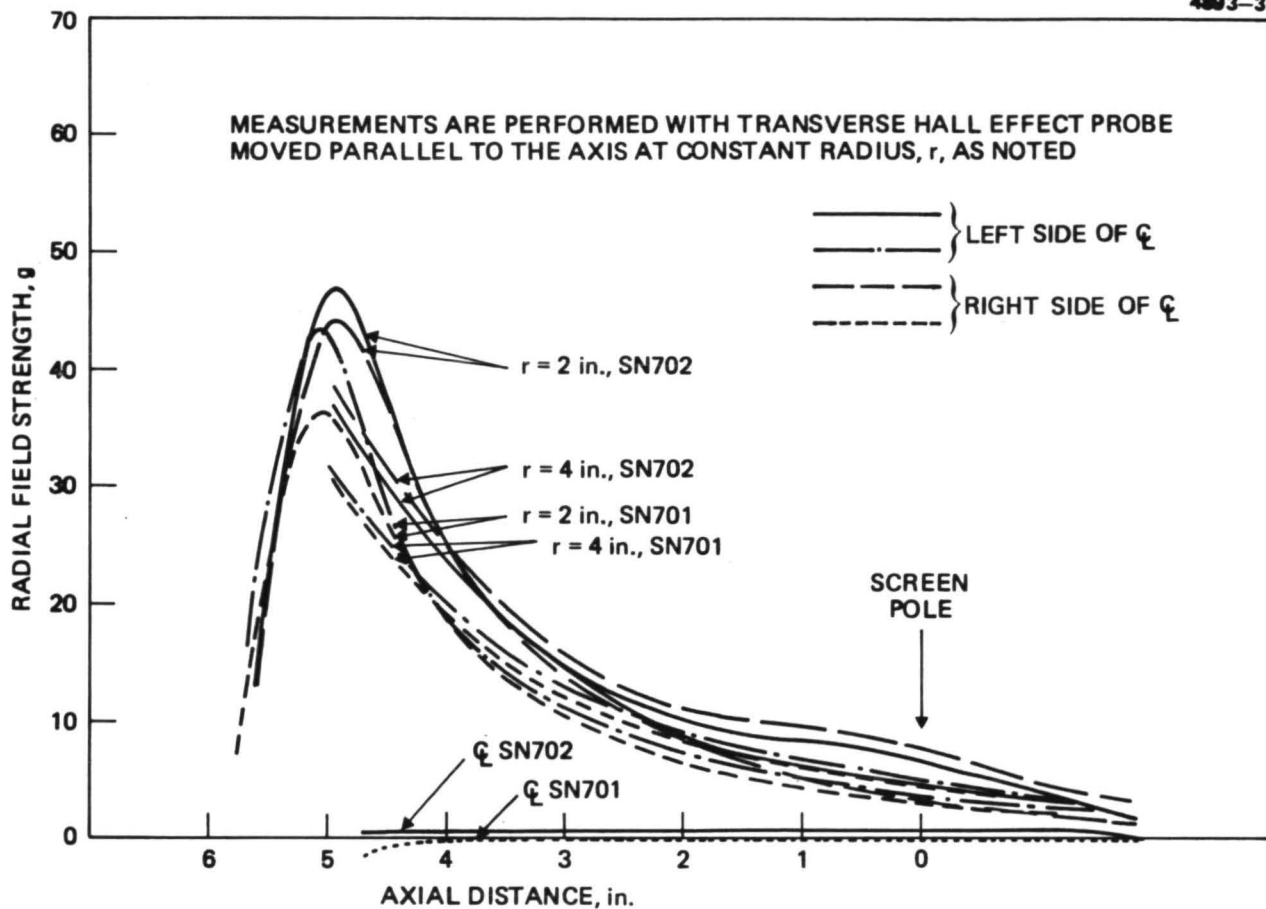
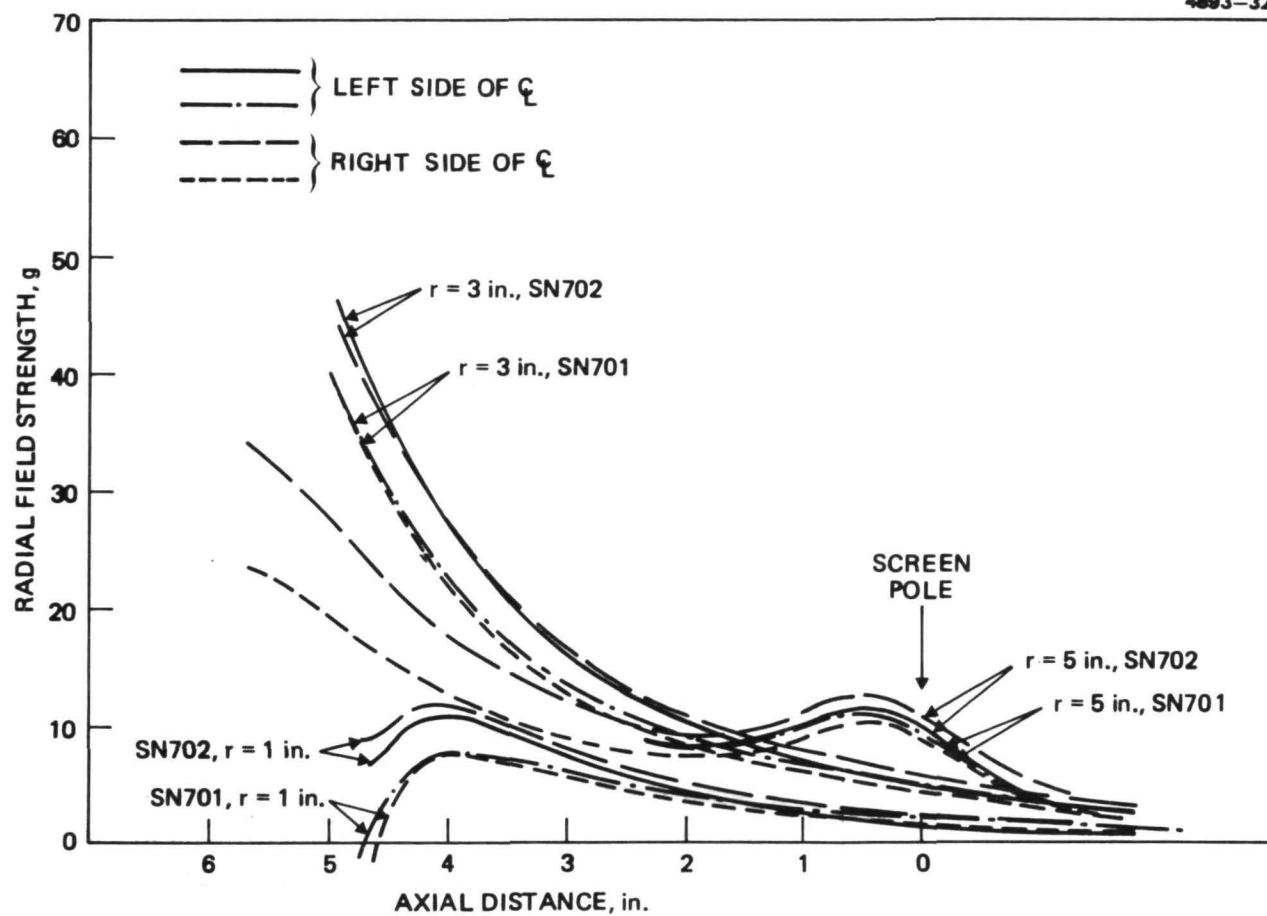
Figure A-18. Comparison of axial magnetic field components of thruster SN 701 after 10,000 hr test with those of thruster SN 702.

Figure A-19. Comparison of radial magnetic field components of thruster SN 701 after 10,000 hr test with those of thruster SN 702.

required for each of the radial magnets is 4.8 to 5.0 G, as measured in the calibrating fixture. The measured values of the radial magnets from thruster SN 701 vary in strength between 4.35 and 4.9 with an average value of 4.5. Thus, assuming that these magnets were originally the same as those being used now, the magnetization appears to have decreased by at least 6% below the value considered to be minimum in new thruster fabrication. This decrease in magnetization can account for at least a part of the generally lower magnetic field components of thruster SN 701 as compared to thruster SN 702 in Figs A-18 and A-19.

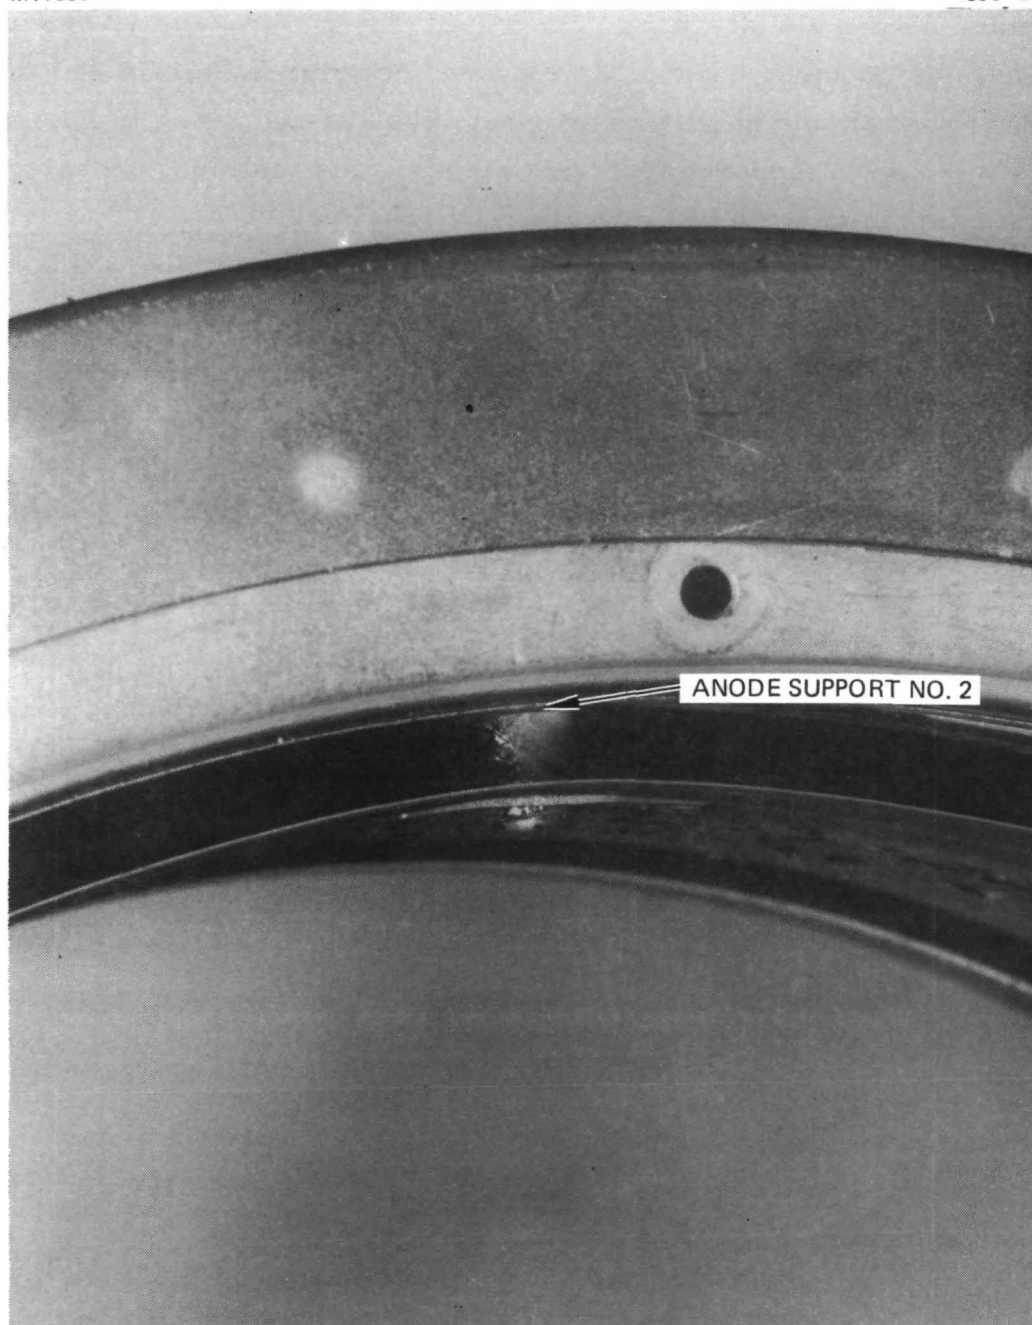
The thruster backplate was removed to expose these support insulators; upon inspection, the ceramics were seen to have sustained damage, as shown in Figs. A-23 and A-24. The damaged insulators were removed intact by cutting the anode and discharge chamber shell with a high-speed abrasive wheel. Removal of anode support number 2 (current connection) resulted in an increase in the leakage resistance, as measured with the "megger" 1 kV ohmmeter, to 10 k $\Omega$ . The megger measurement was seen to fluctuate to readings as high as 25 k $\Omega$ . Removal of the other damaged support, number 6, did not appreciably change the leakage resistance. Figures A-25 and A-26 show all sides of the damaged anode supports after removal from the discharge chamber. The leakage resistance measured across these insulators was approximately 10 k $\Omega$ . Removal of the third upstream anode support, number 4, by normal disassembly increased the leakage resistance to a value fluctuating between 30 and 200 k $\Omega$ ; sparking was seen around the downstream insulators. The remaining anode supports were removed with care taken to preserve a record of their orientation. The ceramic insulators removed are shown in Fig. A-27.

Figure A-23. Anode support No. 2 in place.

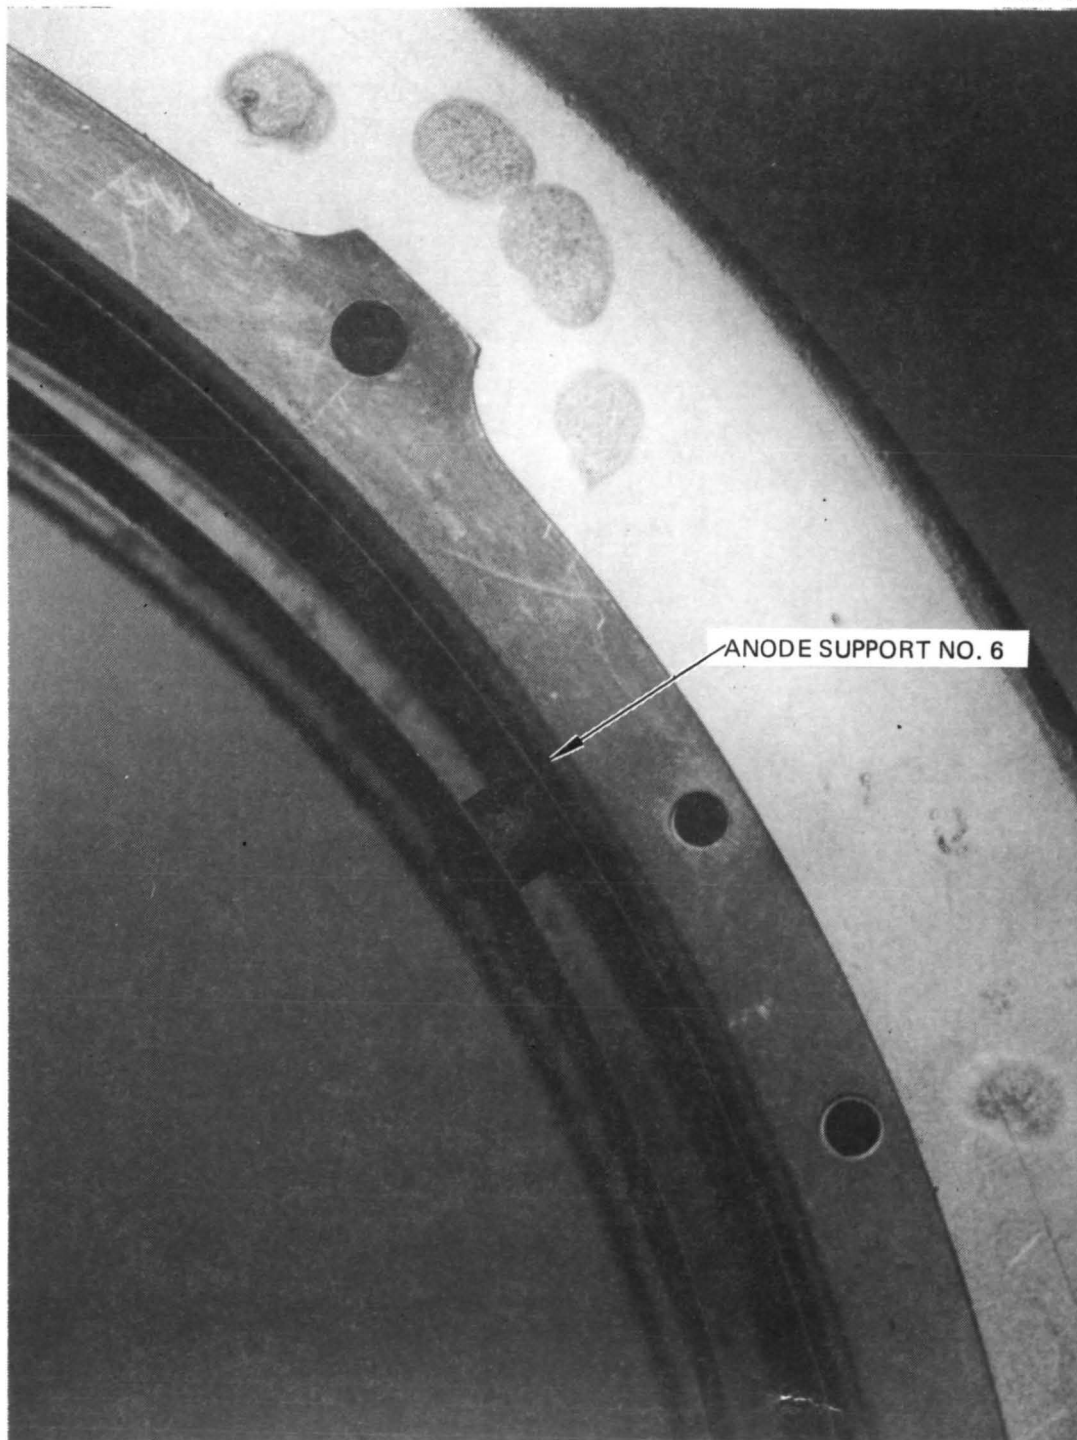
Figure A-24. Anode support No. 6 in place.

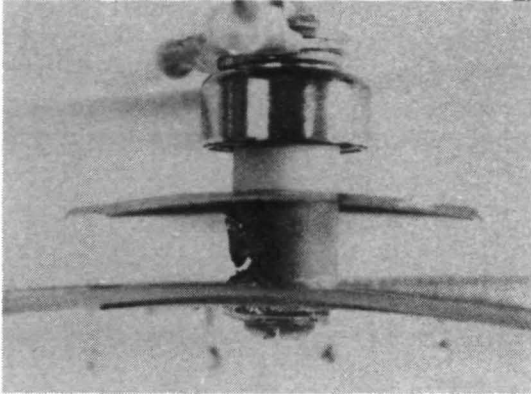
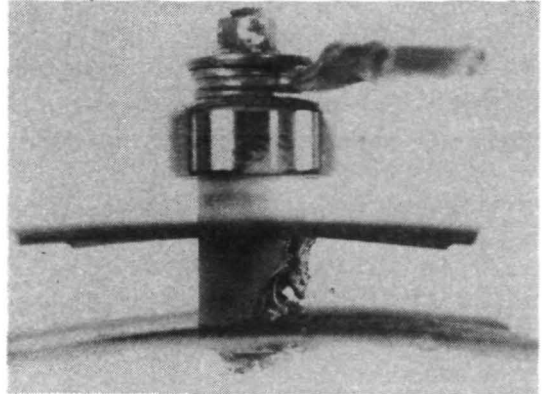
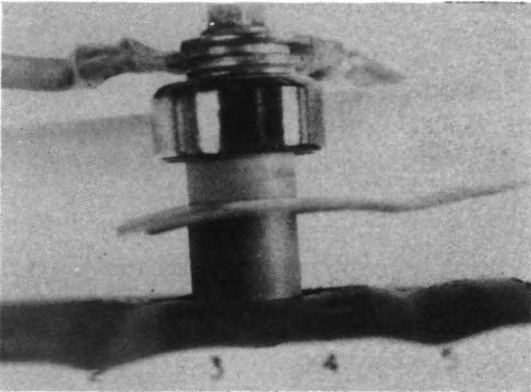
Figure A-25. Damaged anode support No. 2.

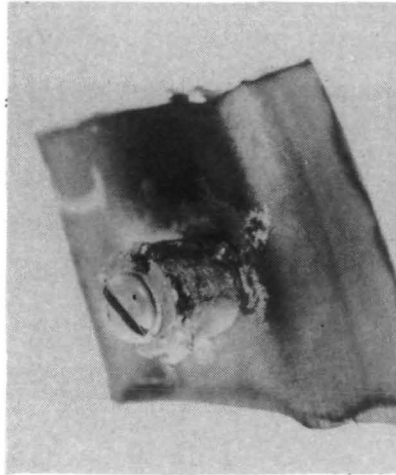
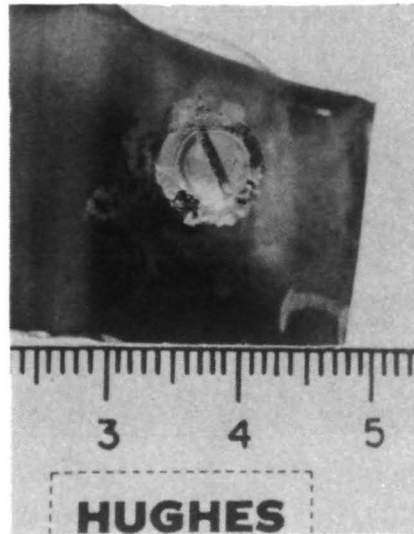
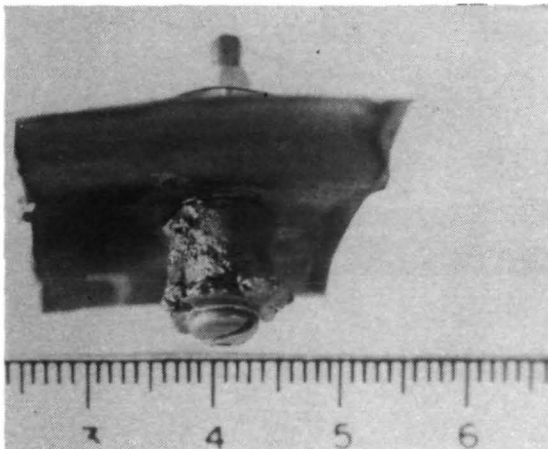
Figure A-26. Damaged anode support No. 6.

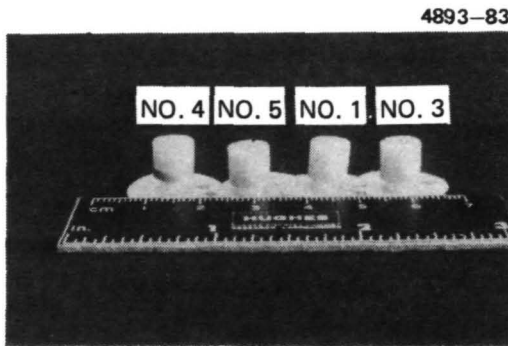
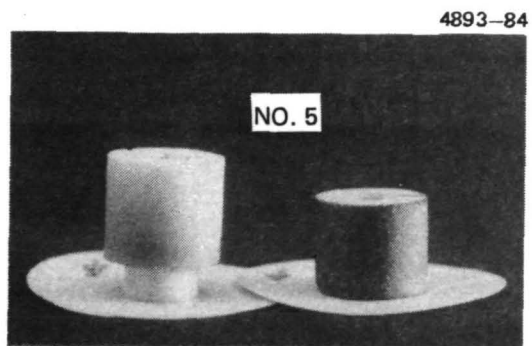
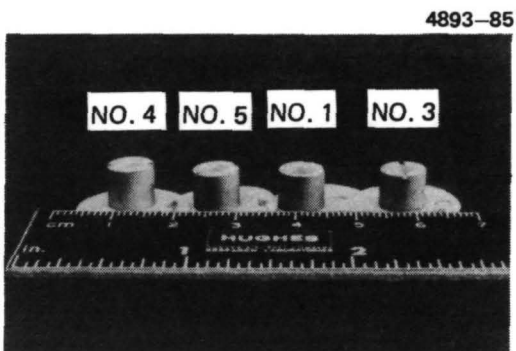
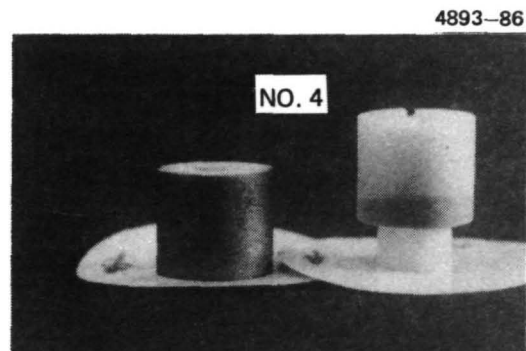
The ceramic parts shown in Fig. A-27(a) are the portion of the anode support insulators which are located on the exterior side of the discharge chamber shell, while those shown in Fig. A-27(b) are located between the anode and the shell. The exterior insulators have a shield and are only slightly coated on the downstream surface (arrows seen on insulator tags indicate beam direction). The interior insulators are not shielded, except by means of their location between anode and shell, and are coated more or less uniformly with no indication of the orientation of the source of the deposited material. The nature of this coating will be discussed later. Figure A-27(c) and (d) show the opposite views

Figure A-27. Cermaic insulators from anode supports  
Nos. 1, 3, 4, and 5.

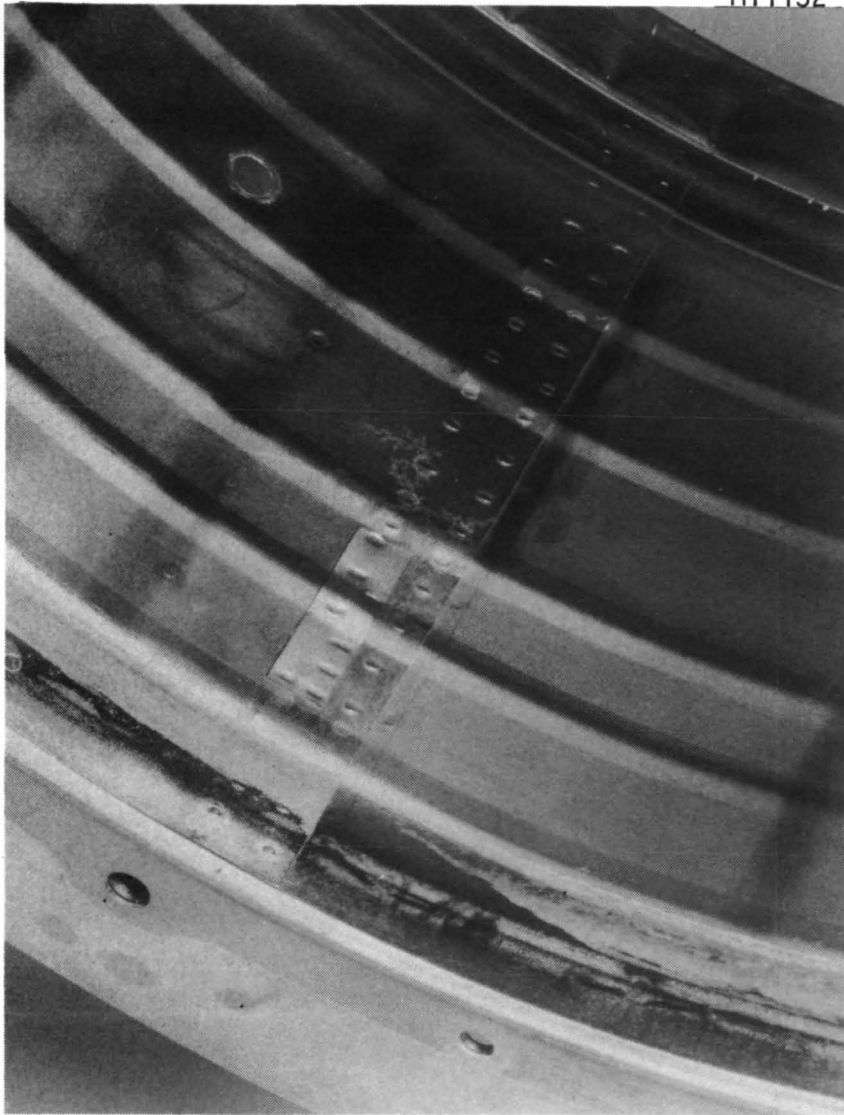
Figure A-29. Part of anode showing support location without "arc tracks."

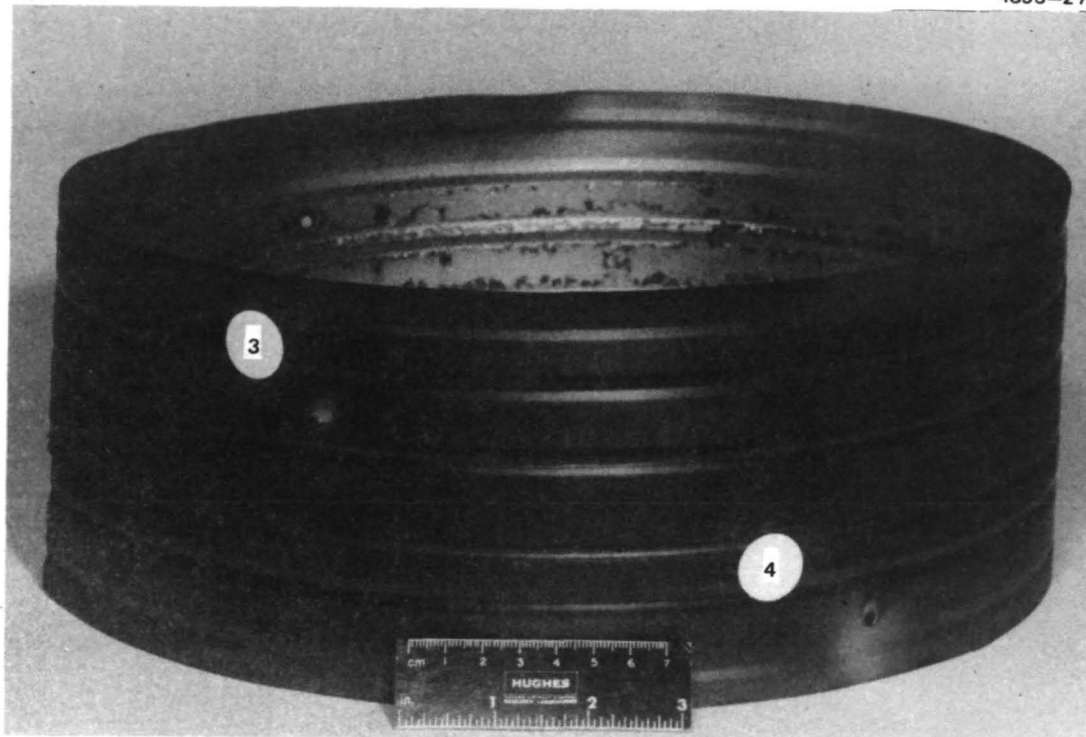
Figure A-30. Exterior surface of anode showing difference in coloration around upstream and downstream support locations.
